Field Report No. 1

Date: March 15, 2023
Project: Strand Theater - Preliminary Demolition
Kosciusko, Mississippi
BSA Project No. 2018

Purpose of Meeting/Site Visit: Site Visit to Review Overall Progress and Discuss Project Completion

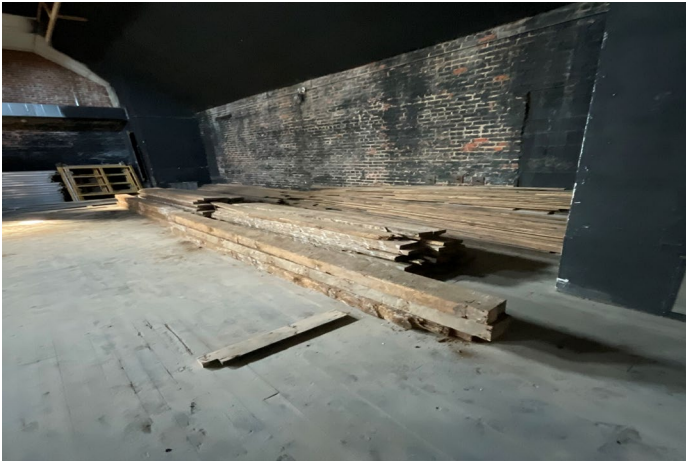
Figure 5 – Salvaged Wood

5. All salvaged wood has been stacked on the stage.
6. RCG has left original Orchestra Pit in place to help maintain and identify original floor levels.

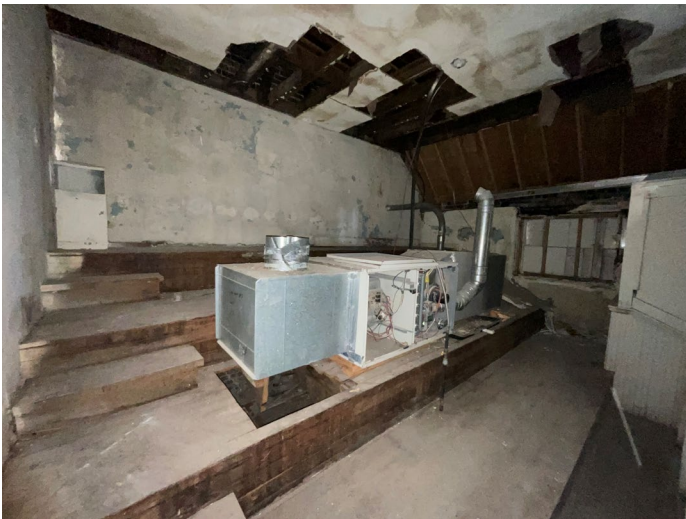
Figure 7 – Mechanical Unit at Balcony and Clerestory Window

3. Mechanical Unit in Back Balcony Room to remain in place (Removal is not in scope of work). All ductwork has been removed from the room and unit.
4. RCG has installed temporary support columns under balcony.

- a. RCG will open the Easternmost clerestory windows on both the North and South Walls as part of the contract scope of work.
 - b. Drywall was removed in the Balcony Mechanical Room to access window (South Side). Window was in good condition and will require installation of a couple temporary plexiglass panes of glass.

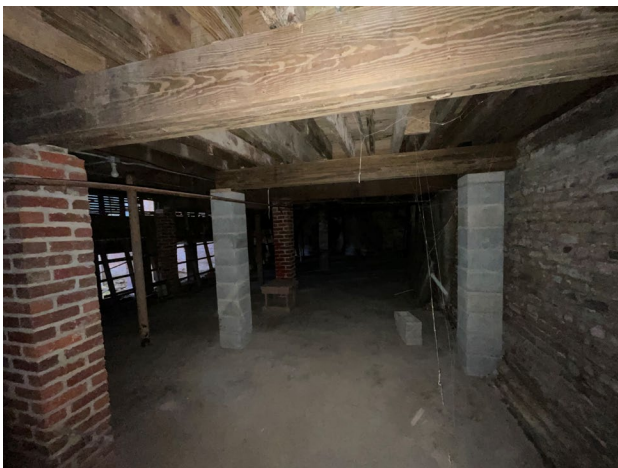
Figure 9 – Basement (Looking North)

1. RCG will contact gas company to make sure all gas is cut off to the building existing lines are free of gas. Remaining piping in basement and theater space will be removed.

7. Any full intact bricks in crawlspace to be salvaged and stacked in common location.
8. Any remaining loose hanging conduit in basement to be removed. Main to be cut off approx. 12-inches below floor.

11. RCG will check to make sure water is turned off at the front Main Water Meter. There is an existing shut off valve approx. 4 feet in from the front (East) wall in the Basement. This will also be shut off and the copper line cut and capped. All remaining copper water piping will be removed.

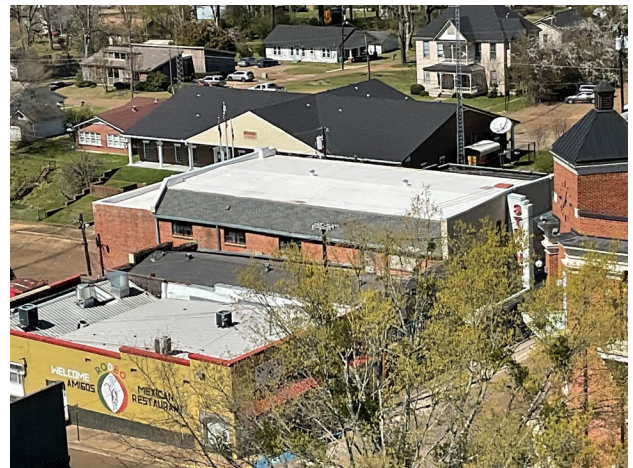
Figure 10 – South Elevation with Clerestory Windows Open

- d. Removal and rebuilding of stairs to basement.
 - e. Removal of walls at upper balcony restroom.
13. Vinyl siding and interior finishes was removed from clerestory windows:

- c. RCG will remove drywall (and exterior vinyl siding) in upper balcony North Room to expose clerestory window and install plexiglass in openings as required.
